# Home Inspection Report

**123 Main St.**

**Upstate, SC 29XXX**

**Report #58XXXG**

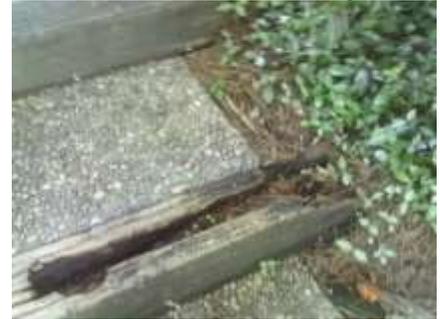
- The asphalt drive has typical cracking. The drive is serviceable and should be for some time. Seal coating helps reduce deterioration from water penetrating in cracks. Herbicides can be used at the edges so grass will not grow into the asphalt so readily.
- The driveway drain was not tested for functional flow. It should be flushed out periodically to determine if open and where water is discharging.
- The wood retaining wall along the front of the property and the wood in the right side walk was noted to be deteriorated in areas. See photo for example. Repairs do not appear to be essential at this time. However, repairs will be needed at some point in the future.

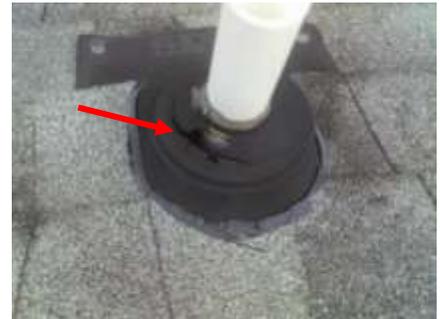
**MINOR REPAIR:** The flashing/rubber boots around the sewer vent pipes are cracked where the pipes extend through the boots, which typically allows for leakage.

- The sewer vent pipe boots are made of a rubber-type material. These boots crack over time where the sewer vent pipe goes through them, due to stress and weather. These rubber boots can and do leak when they crack. These boots should be monitored for cracks and repairs made to the boots when they crack, to eliminate water seepage.

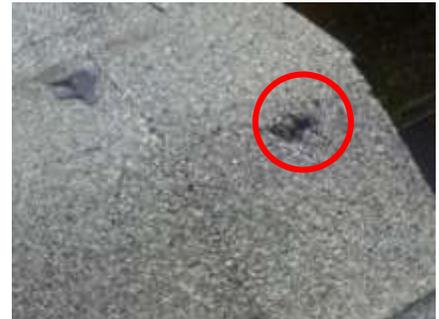
**NOMINAL REPAIR:** There is a hole in the end ridge shingle at the front end peak of the roof over the garage. See photo.

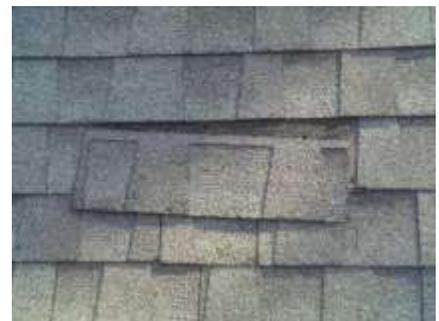
**NOMINAL REPAIR:** There is a loose shingle between the front right skylights. See photo.

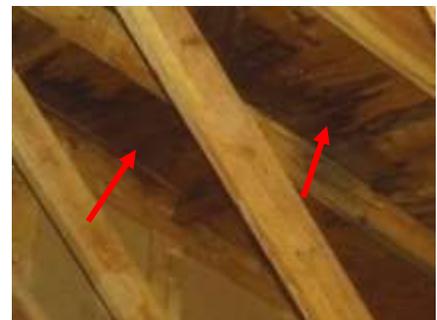
- There is a large stain on the roof decking below the cupola over the garage. See photo. This stain tested dry at the inspection with a moisture meter. Per the disclosure, there was a leak here in the past which has already been repaired. Monitor for leakage in the future.

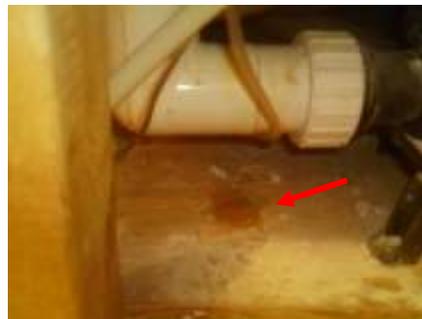
**MINOR REPAIR:** There is a slow leak in a supply pipe above where the far left end water heater is installed (note wet stain on the floor here).

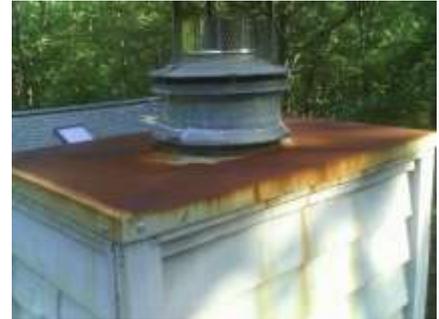
**MINOR REPAIR:** Surface rust has formed on the metal cap at the top of the chimney. See photo. This should be controlled to prevent rust through.
