Home Inspection Report

100 Maple Wood Lane

Greenville, SC 29605

Report #5000W

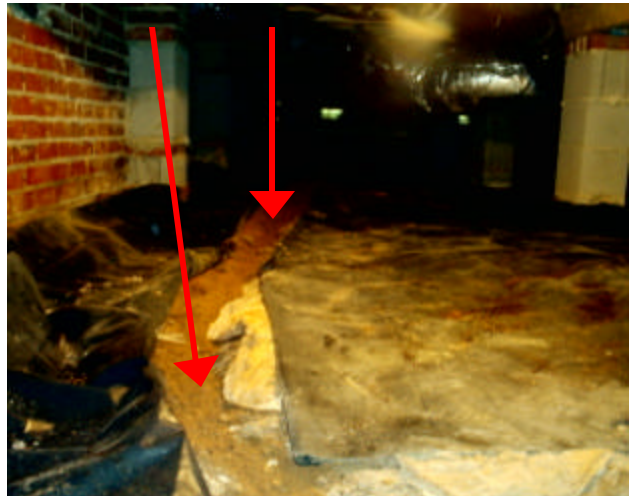
- Evidence of past water penetration was observed. Some moisture penetration is fairly typical for homes in this area. No signs seen of the water in the crawlspace causing a significant moisture or humidity problem. The moisture content of the framing was within a normal range and there is only minor staining and little mildew or mold that are present in most crawlspaces. If there is a large amount of rainwater during a short period of time, some water accumulation may be noticed. Some "trenches" have been dug in areas of the crawlspace to help divert moisture penetration towards the positive drain located at the left rear corner of the crawlspace. See photo at right showing one of the "trenched". Further corrective measures do not appear to be essential; however, it would be beneficial to reduce the amount of water in the crawlspace. This can usually be done by piping all of the downspouts'

water away from the foundation walls. If the termite inspection is performed after a rainy period and there is any standing water in the crawlspace, a sub-surface type drain may be required to issue a clear termite/moisture control letter. This could happen now or when you sell the home.

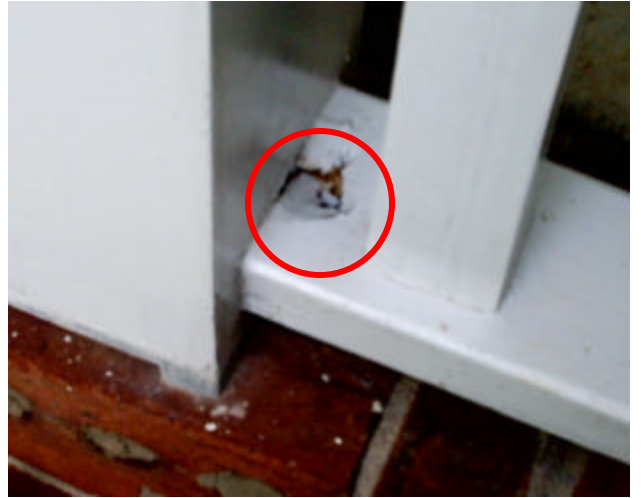
MINOR REPAIR: Damaged wood seen at the front porch's rails. Photo at right shows an example of this damage.

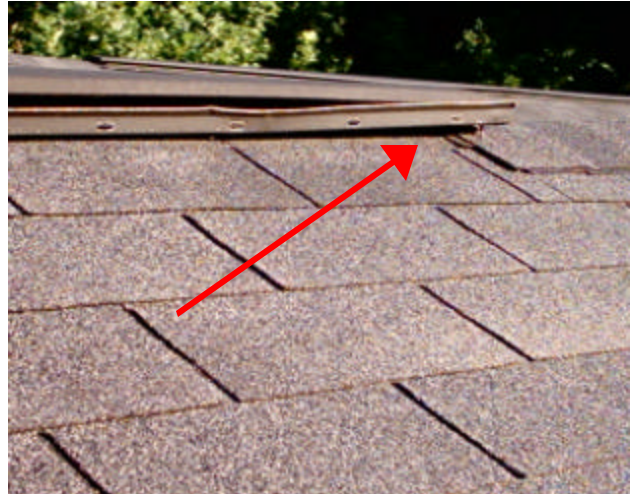
NOMINAL REPAIR: Some of the metal ridge vents are loose in areas. Photo at right shows one of the loose vents. Screwing these vents in place, as opposed to nailing them like they are now, tends to secure them better.
