# Home Inspection Report

**BUYERS' INSPECTION GROUP, INC.**

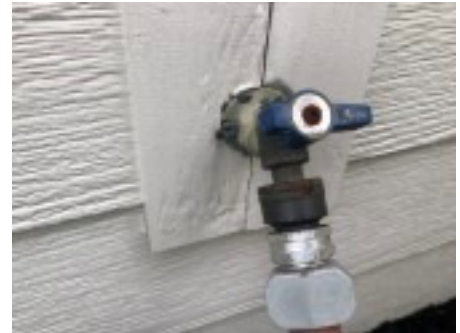
**NOMINAL REPAIR:** The mounting trim block for the right-side exterior spigot is damaged/rotten. See photo.

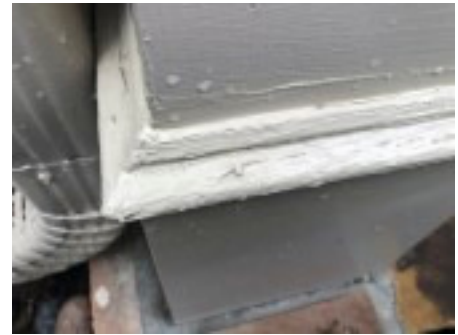
- The wood trim in various areas around the house have had open joints, allowing water to enter. If repairs are not made, these areas will rot. Recommend sealing and painting these areas. Concealed damage may be revealed during repairs. Some of the probed areas may be more obvious now.

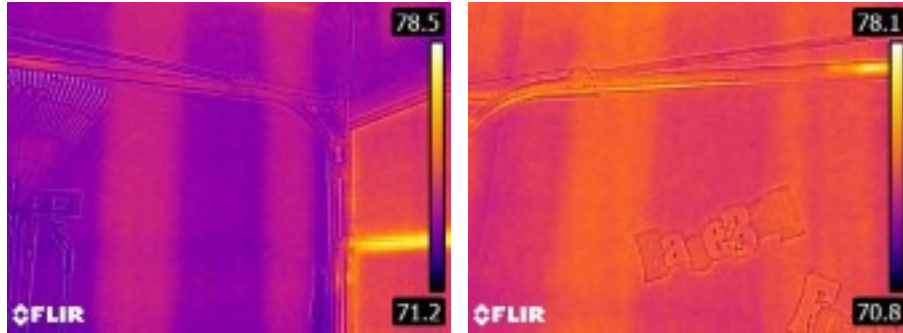
**INVESTIGATE FURTHER:** There are "plugs" in areas at the top of the left and right garage walls indicating that insulation most likely has been blown into these walls. The presence of the insulation and/or its adequacy is unknown and excluded from this report. Ask owner about these areas.

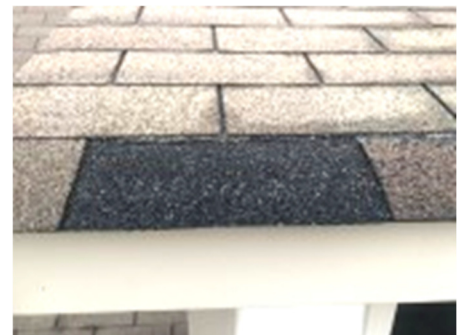
**NOMINAL REPAIR:** A missing shingle tab was observed at the front dormer roof. See photo.

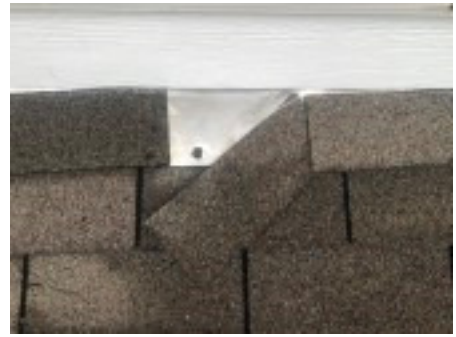
**NOMINAL REPAIR:** A slipping shingle was observed at the flashing area of the front dormer. See photo.

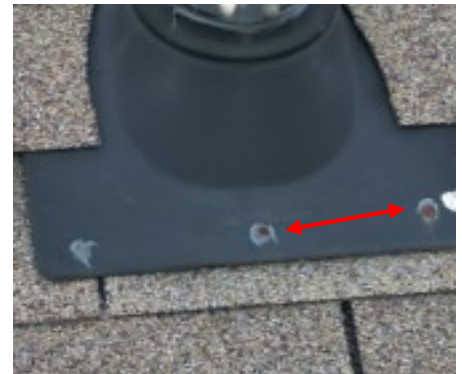
**NOMINAL REPAIR:** Some of the sewer vent pipe boots are top-nailed and have exposed nail heads. See example in photo.

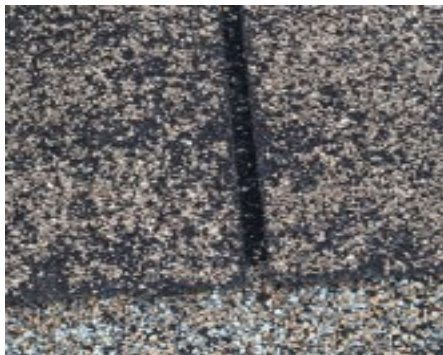
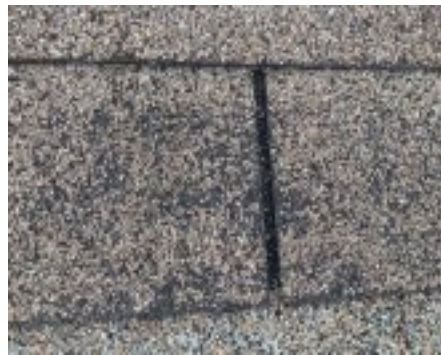
**INVESTIGATE FURTHER:** The roofing material is showing wear in areas. There is significant granule loss in areas. See examples in lower photos. This roof should not be expected to last many more seasons. Have roofer inspect these areas to determine if repairs or replacement is needed.

**INVESTIGATE FURTHER:** Recommend having the licensed roofer inspect the entire roof and its flashings when he is out making the above listed repair(s), and make any other needed repairs at that time, especially since many homes have had weather-related damage due to recent storms in this general area. See related remarks below.

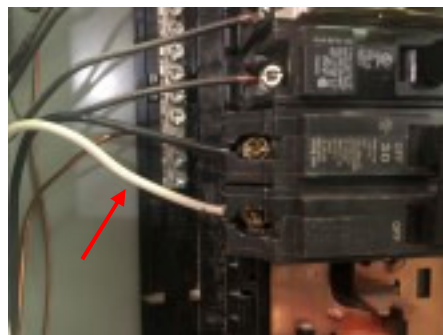
**NOMINAL REPAIR:** The white electrical wire connected to 240-volt breaker in the branch panel in the garage HVAC is not labeled as power wire (white wire not labeled or marked as a power/hot black). See photo

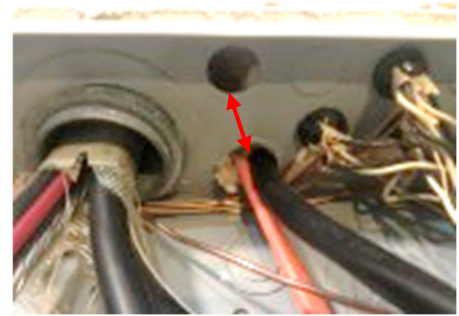
**NOMINAL REPAIR:** An open area (open knock out) was found in the main electrical panel box. See photo. All openings should be sealed.

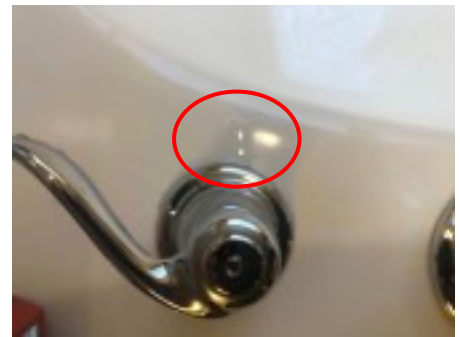
**NOMINAL REPAIR:** MBR Bath: A small leak was found at the tub's cold water fixture handle when operated. See photo.

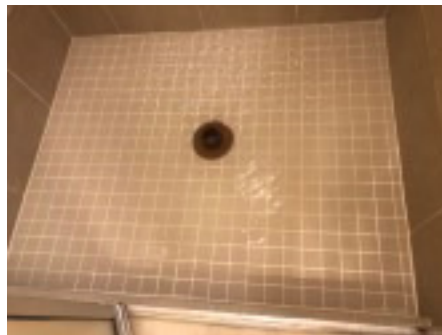
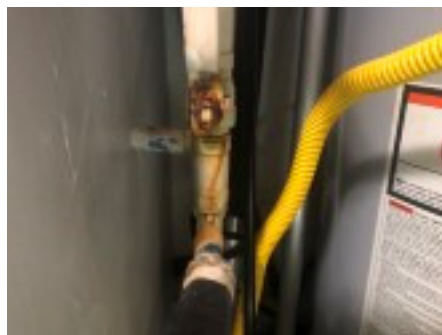
- Corrosion of metal pipe fittings was observed at the main water cut off area. See photo. No leakage was seen, but corrosion should be interpreted as having leakage potential.
