# Home Inspection Report

**BUYERS' INSPECTION GROUP, INC.**

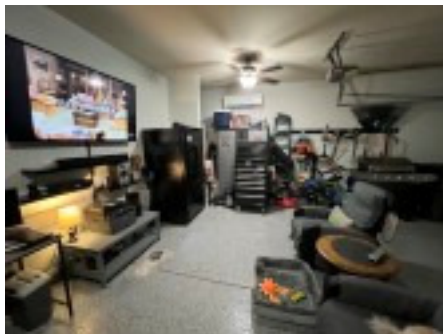
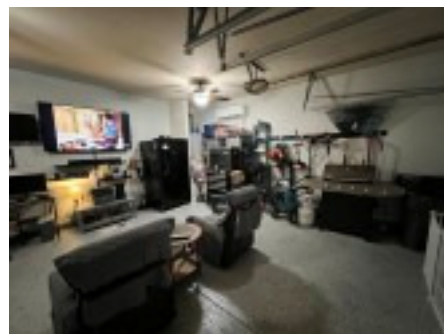
- Minor cracking was observed. These are typical for this type of foundation and floor. Most concrete slabs can be expected to crack.
- Items were stored in this area, which obstructed much of the slab and base of the walls. See examples in lower photos. There could be discrepancies such as cracks, settling, or termites that were not visible because of the stored items. While there are no visible signs of any of these problems, the slab should be observed when the items are removed.<sup>3</sup>

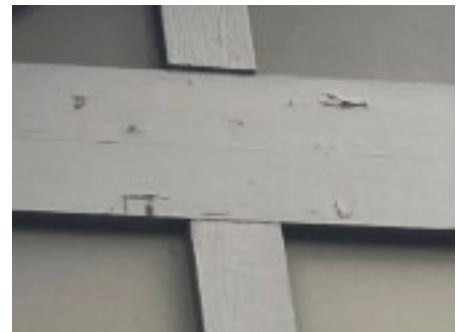
**NOMINAL REPAIR:** The mounting trim block for the right-side exterior spigot is damaged/rotten. See photo.

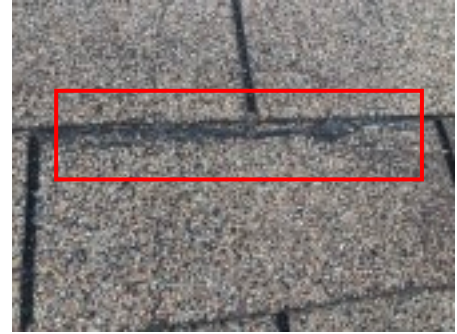
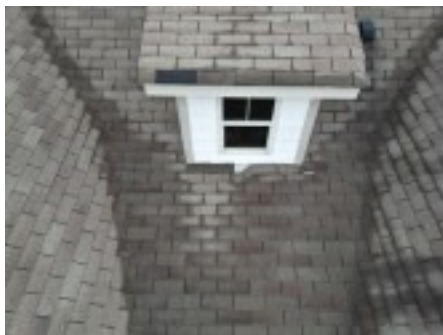
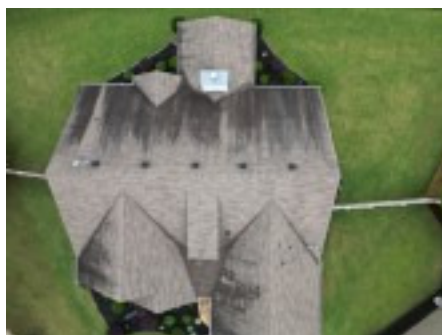
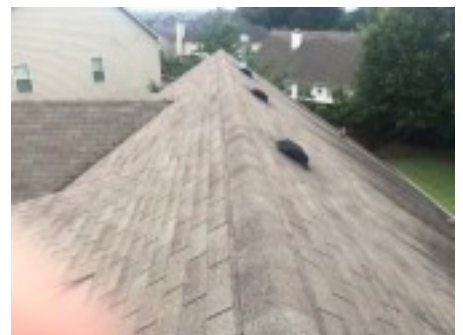
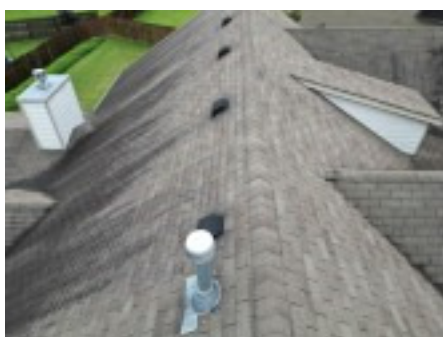
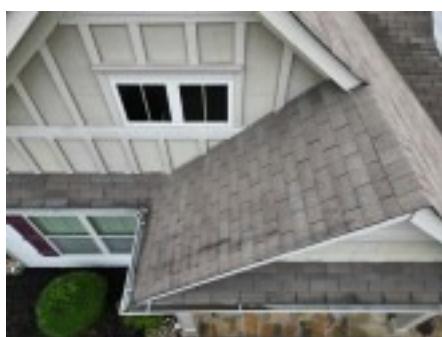
- This roof was viewed by walking on the front area, from the ground with binoculars and from the air by a drone, due to its height and steepness and loose granular. When viewed in this manner, some deficiencies in the roofing materials may not be visible. Hail damage, which causes small pops or divots in the roof materials, most likely will not be seen. The homeowner should be consulted to determine if they are aware of any hailstorms that may have caused damage to their roof and/or neighbor's roofs. If so, the homeowner should contact their insurance company for further inspection and a possible claim.

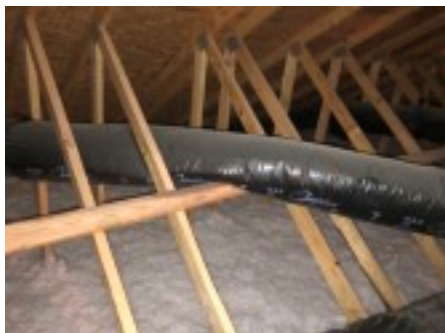
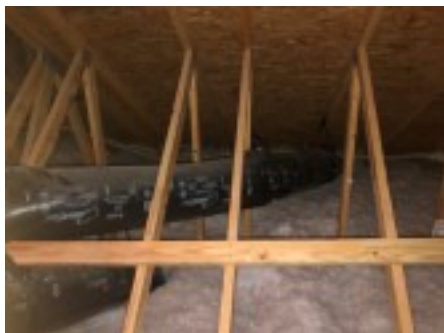
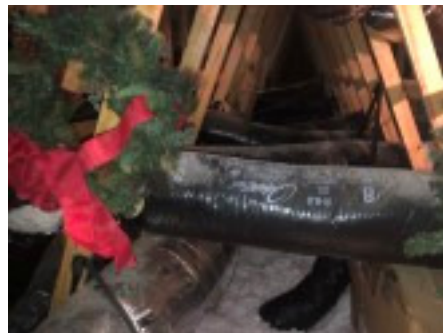
- The remote areas of the attic that are not readily accessible were not inspected because of limited or no accesses, due to the design and undisturbed insulation. Conditions in these areas (including watertightness of the roof, framing, insulation, etc.) are unknown and are specifically excluded from the inspection and report.

- Nearly all attics have water stains. Light stains indicate leaks of short duration, and many of these happen during construction. Unless it has rained recently and these stains are wet, or there is an obvious deficiency on the roof, it is not possible to determine if light stains are old leaks or one that started recently. Black stains, which may also be rotting, indicate leaks over a long period of time. Leaks that cause black stains are usually fairly small and are not enough to cause water to leak into the attic where they would be seen. Stains were seen in this attic. Recommend periodically checking the attic while it is raining.

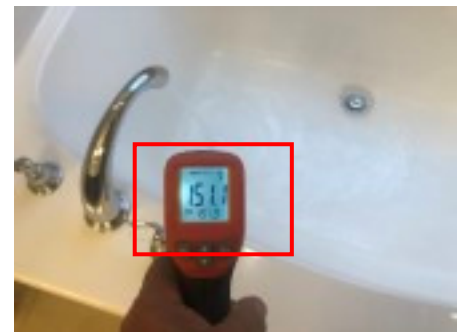
**SAFETY CONCERN:** The hot water temperature measured 151.1°. Hot water above 120 degrees can scald. The present temperature is too hot and should be lowered. This is especially true if small children, infants, or the elderly will be living in the home.

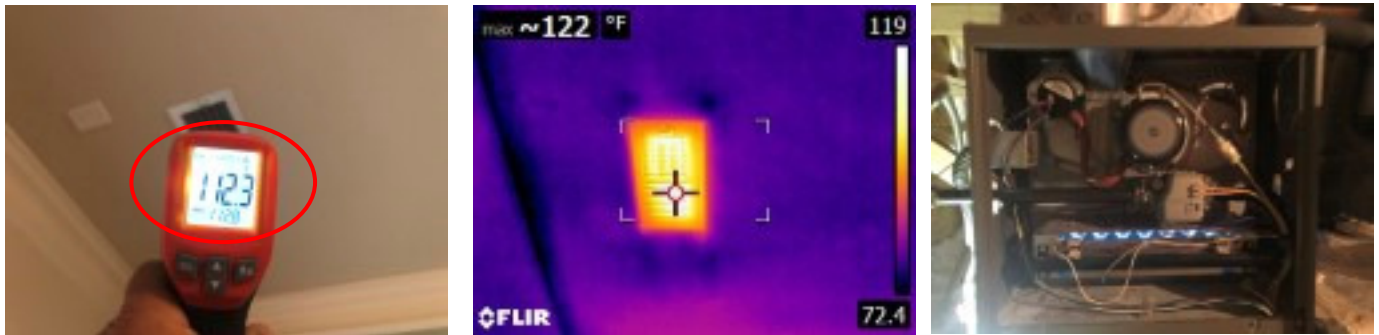
- The gas furnace was visually examined and operated using normal controls. It appears functional. No problems were seen with the flue pipe. There is no access to view the heat exchanger, due to the design of the furnace, without disassembly. See footnote below.<sup>16</sup>

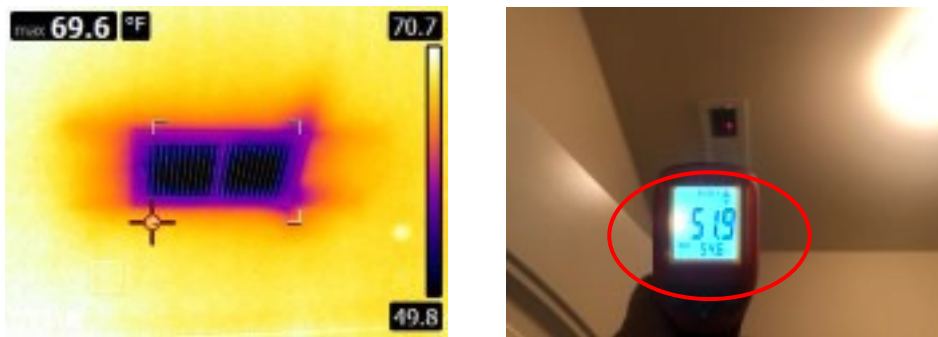
- The air conditioning system was operated during this inspection. The running signs, amp draw, temperature drop, and operation were all within acceptable ranges.

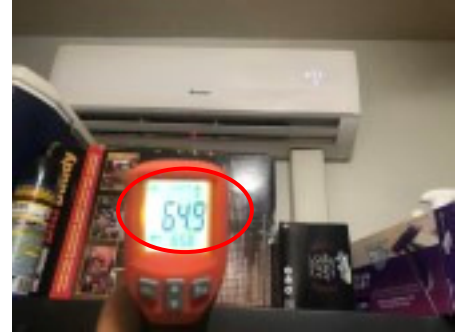
- The mini split ductless heat pump was operated in the cooling mode only. Temperature drop and amp draw were typical. It appears functional.<sup>18</sup>

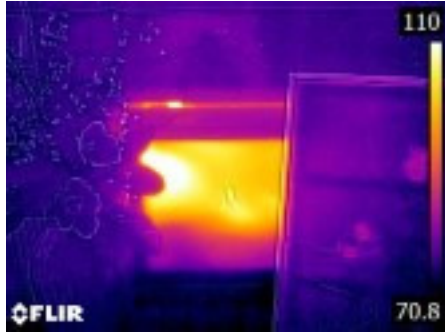
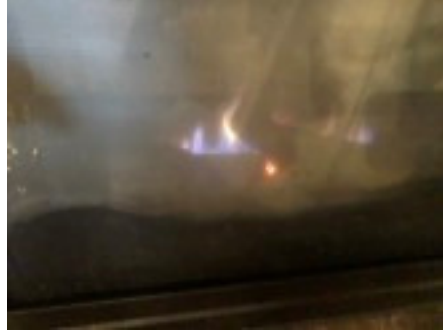
- Gas logs were in the fireplace, and these were operated. Since there are gas logs in the fireplace, it is recommended that you install carbon monoxide detectors, for safety.<sup>20</sup>
- There are gas logs installed inside the firebox. It was not determined if these gas logs are designed and/or approved for this fireplace. It is not known if these gas logs are installed in accordance with the manufacturers' specifications. Recommend checking with the fireplace and gas log manufacturers for further information.

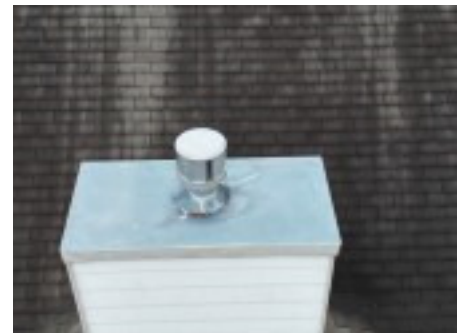
- The metal chimney flue and inside the chimney were not fully visible from the attic. Conditions of the components in these areas are unknown and are specifically excluded from the inspection and report.
